Administrative Order Docket No. V-W-11-AO-05

CWA COMPLIANCE EVALUATION INSPECTION REPORT U.S. ENVIRONMENTAL PROTECTION AGENCY, REGION 5

Purpose: Compliance Evaluation Inspection	
Facility: Ex. 6 (Personal Privacy) Farms, Ltd.	
Ex. 6 (Personal Privacy)	
NPDES Permit Number: N/A	
TVIX	
Date of Inspection: September 28, 2016	
September 28, 2010	
EPA Representatives:	210 007 2705
Joan Rogers, Environmental Scientist	312-886-2785
State Representatives:	(10,000,7000
Mr. Bruce Rodely Bruce.rodely@illinois.gov	618-993-7200
	618-993-7200
Mr. Brian Rodely <u>Brian.rodely@illinois.gov</u>	
Ex. 6. (Personal Privacy) Owner	Ex. 6. (Personal Privacy)
Report Prepared by: Joan Rogers, Environmental Scientist	
Report Date: March 28, 2017	
Inspector Signature and Date:	0 3/28/17
Approver Signature: / Dalu	
Approval Date: 4/19/17

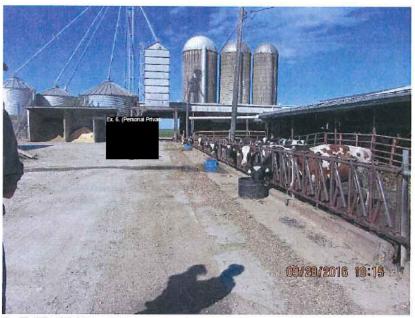
Description: Open alley along the freestall barn has concrete curbing to prevent manure and process wastewater from leaving the pen. Commodities building in back has all commodities under roof.

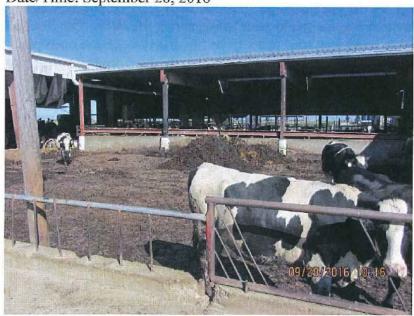
2: IMG 0104

Description: Manure stacking inside the pen. Gutters and downspouts divert clean roof water away from open pen.

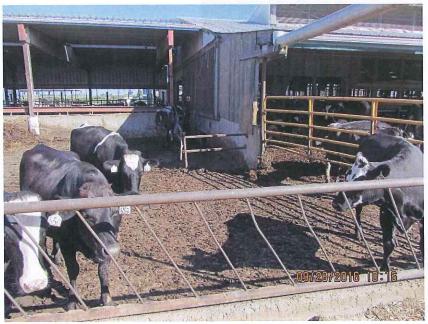
Description: Overhead gutter diverts water from the open pen.

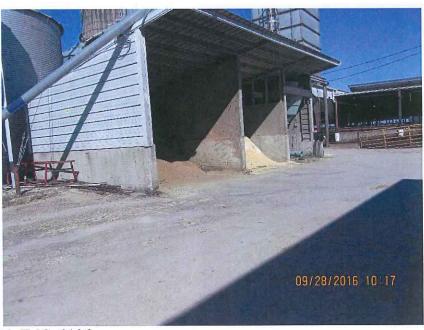
4: IMG 0106

Description: Commodities building. All feed products are maintained under roof.

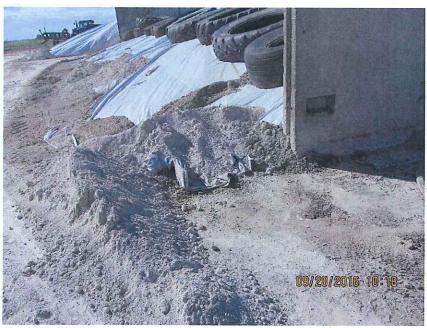
Description: Leachate from the silage bunker would flow from this corner to a pit.

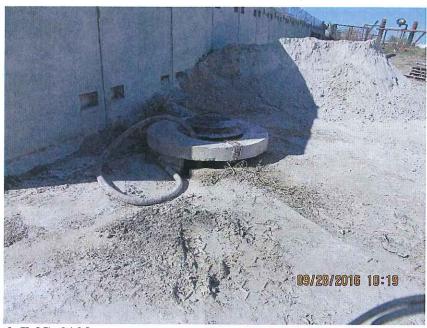
6: IMG 0108

Description: Pit collects silage leachate. Facility owner visually inspects pit for level process wastewater in the pit and when full, it is pumped out.

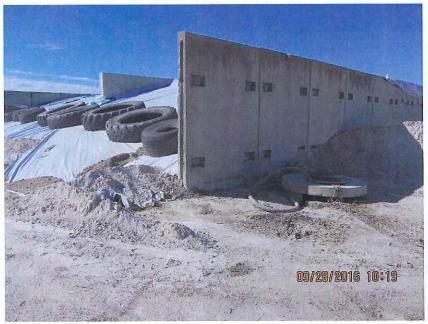
Description: Overview of the silage bunker and the pit that collects the silage leachate.

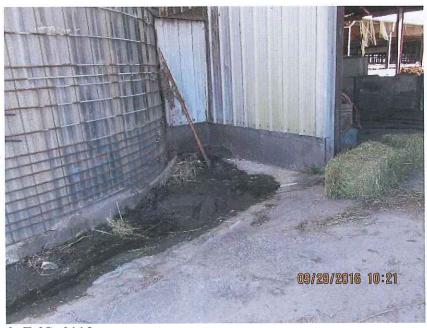
8: IMG_0110

Description: A spring leaks water from the ground to the base of the silos.

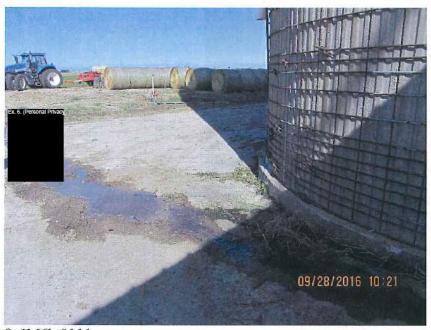
Description: Spring water flows over the ground near the silos.

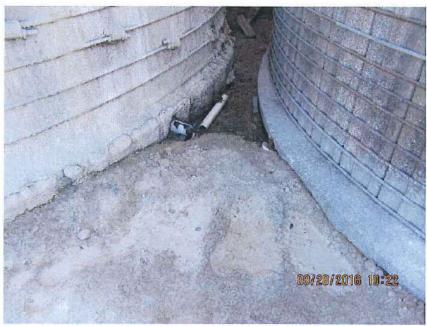
10: IMG 0112

Description: Any process wastewater from the silos goes into inlets at the base of the silos and

from there it is piped underground to a manhole.

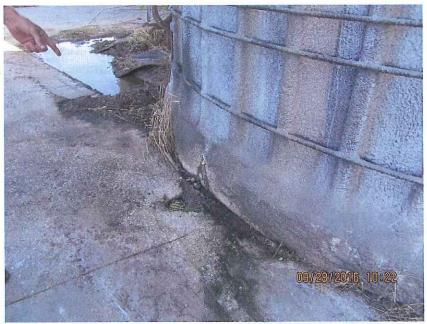
Description: Another inlet for piping that transports process wastewater to a manhole.

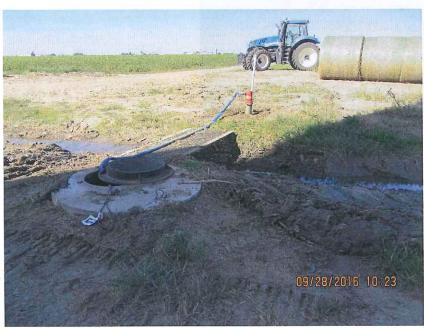
12: IMG 0114

Description: Process wastewater from the silos is piped underground to this manhole. From the manhole, the process wastewater is then piped to Pond #2.

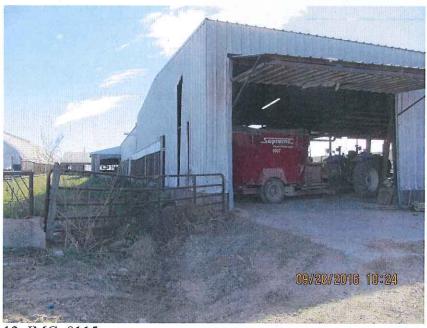
13: IMG 0115

Description: Feed mixer kept in barn. There was formerly an outdoor pen to the left of this barn.

The pen has been decommissioned.

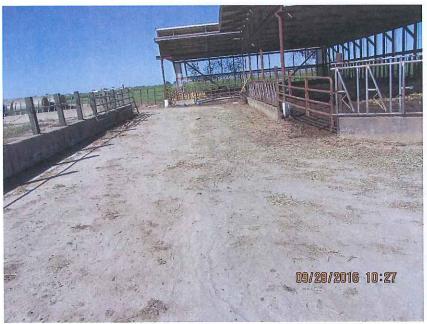
Description: Decommissioned pen on the left hand side of the photo. Process wastewater from

the concreted areas would flow with precipitation to Pond #2.

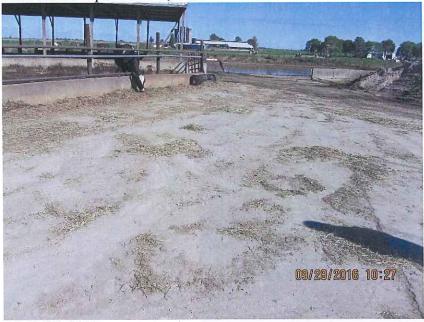
15: IMG 0117

Description: Process wastewater from this concreted area would flow with precipitation to Pond

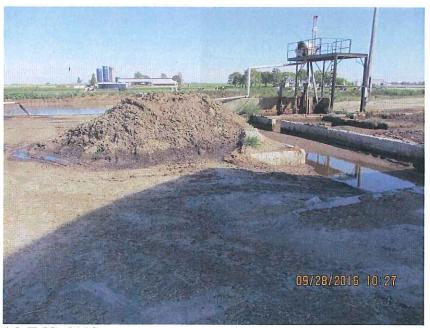
Description: Recycled sand is stacked on the concrete to dry. Process wastewater from the sand

would flow to Pond #2. Location: South of Pond #2 Camera Direction: North

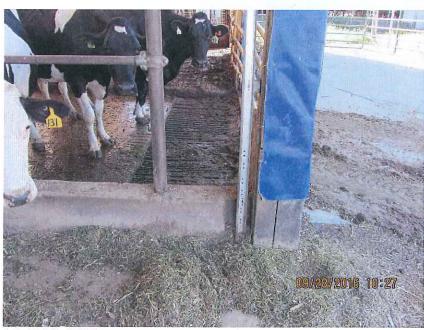
17: IMG 0119

Description: Gutter inside barn collects manure and process wastewater from the barn.

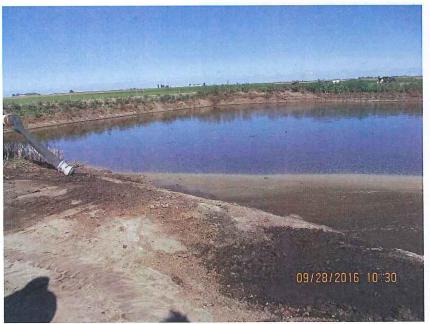
Description: Manure Pond #2 had sufficient freeboard on the day of the inspection.

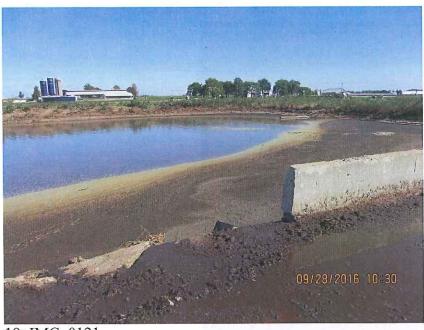
19: IMG 0121

Description: Manure Pond #2 had sufficient freeboard on the day of the inspection.

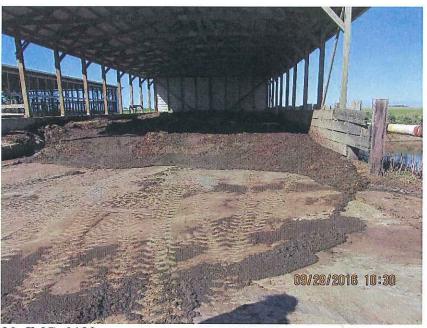
Description: Solids stacking inside barn at the northwest corner of the facility. Leachate would

flow to Pond #2.

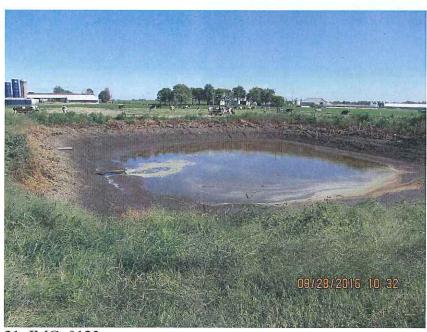
21: IMG_0123

Description: Pond #1.

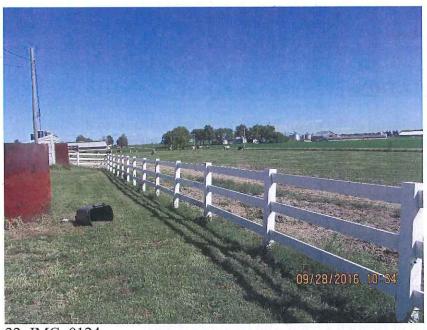
Description: Cows in the pasture to the north and east of the manure ponds.
